Manhole Inspection Summary

Manhole # S25CC1024MH

Location Address: **1302 BERRY ST**

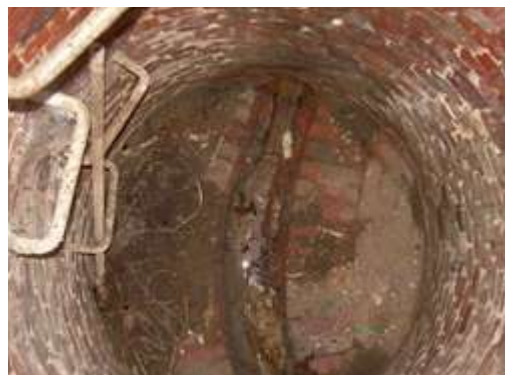
Top View

Bench and Channel debris.

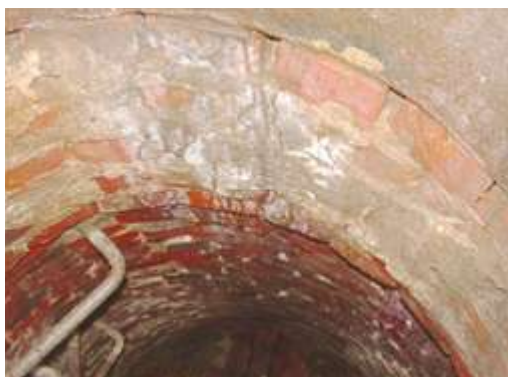
Defect

Frame Offset: **1** (in.) Condition: ☐ Sound ☐ Cracked ☒ **Leaks**

Condition: ☐ Sound ☐ Cracked ☐ Root Intrusion ☐ Loose Brick ☒ **Deteriorated**

Infiltration: ☐ None ☒ **Joint** ☐ Cracks ☒ **Mortar** ☐ Roots ☐ Wall

Infiltration: ☐ None ☐ Joint ☐ Cracks ☒ **Mortar** ☐ Roots ☒ **Wall**

Frame leaks. Adjustment deterioration and infiltration. Barrel infiltration.

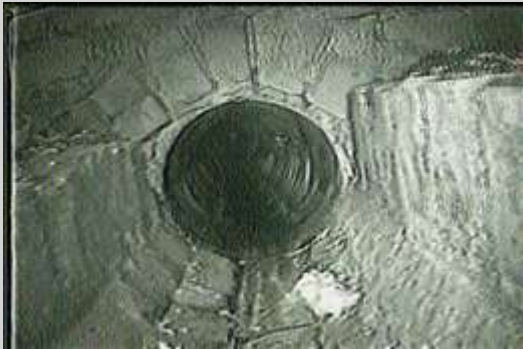
8 in. Circular Gravity Sewer Pipe Out @ 12 O'Clock

Infiltration: **None** Pipe Seal Cond: **Cracked**
